**Flood Control Project Maintenance  
Levee Inspections**

**Maintenance Issue Types Only, Levee Inspection Report By Mile - Fall 2016**

**Plumas County**

| Waterway | Bank | Unit Miles | Inspection Start/End | Inspector |
|---|---|---|---|---|
| Unit No. 01 North Fork Feather River | Left | 1.89 | 10/07/2016<br>10/07/2016 | Tariq<br>Chechi |

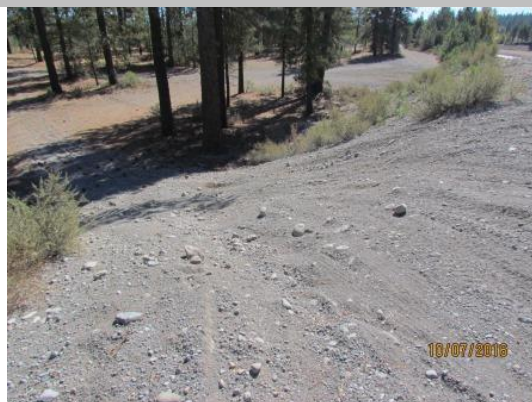
Photo 1 of 1 : FA\_2016\_NA0015\_337\_15\_20161019\_00015.jpg

| Item | Slope Stability | | | 40.273274 ° | 40.273274 ° |

View of the damaged slope by vehicle traffic.

| S3 : Repair the levee slope damaged by vehicle traffic and prevent access where possible. | | | | | |

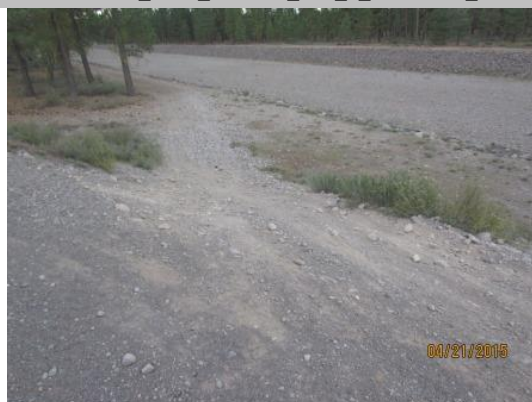
Photo 1 of 1 : FA\_2016\_NA0015\_337\_9\_20160823\_00007.jpg

| Item | Slope Stability | | | 40.279790 ° | 121.249850 ° |

View of the vehicle erosion along the waterside toe.

| S3 : Repair the levee slope damaged by vehicle traffic and prevent access where possible. | | | | | |

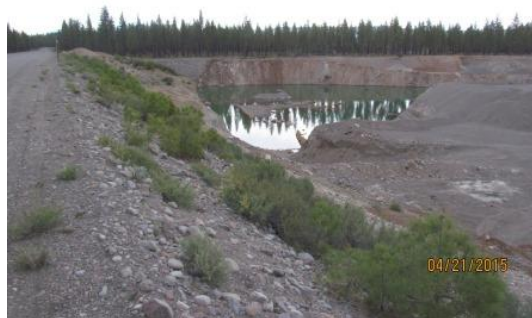
Photo 1 of 2 : FA\_2016\_NA0015\_337\_7\_20160823\_00004.jpg

| Item | Slope Stability | | | 40.290758° | 40.291987° |

View of the area where the contractor has removed the material from toe of the levee.

| S1 : Repair slope instability. | | | | | |
| The landowner needs to replace the material that has been removed from the toe of the levee. | | | | | |

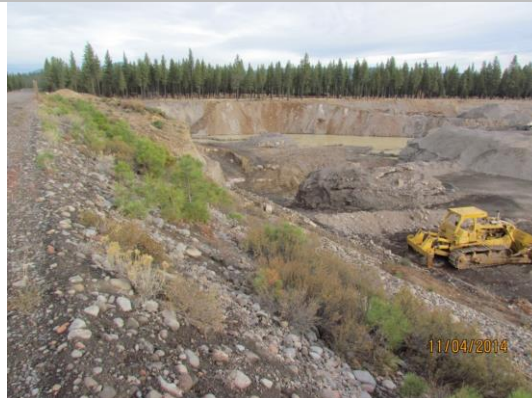
Photo 2 of 2 : FA\_2016\_NA0015\_337\_7\_20160823\_00005.jpg

View of the area where the contractor has removed the material from toe of the levee.

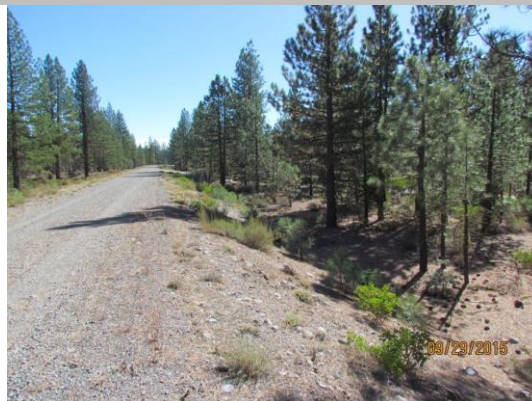
Photo 1 of 1 : FA\_2016\_NA0015\_338\_1\_20160823\_00002.jpg

| Item | Vegetation | | | 40.286415 ° | 40.271743 ° |

View of the small pine trees and other vegetation growing on the slope.

| V2 : Remove the wild growth other than native grasses from the levee slopes. | | | | | |
| Mow or remove the pine trees and other vegetation from the slope. | | | | | |

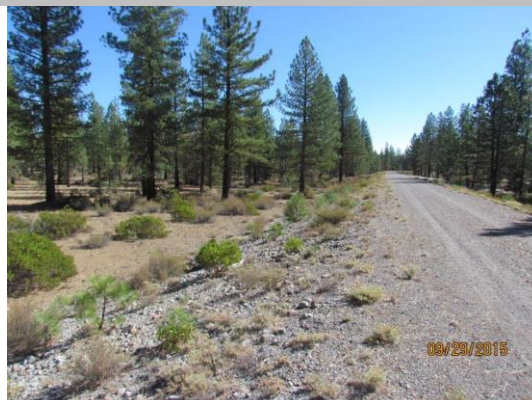
Photo 1 of 1 : FA\_2016\_NA0015\_338\_2\_20160823\_00004.jpg

| Item | Vegetation | | | 40.286415 ° | 40.271743 ° |

View of the small pine trees and other vegetation growing on the slope.

| V2 : Remove the wild growth other than native grasses from the levee slopes. | | | | | |
| Mow or remove the pine trees and other vegetation from the slope. | | | | | |

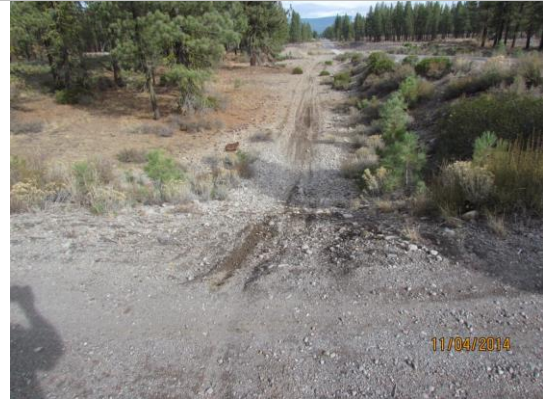
Photo 1 of 1 : FA\_2016\_NA0015\_338\_5\_20160823\_00006.jpg

| Item | Slope Stability | | | 40.281950° | 121.253710° |

View of the vehicle erosion on the waterside slope.

| S3 : Repair the levee slope damaged by vehicle traffic and prevent access where possible. | | | | | |
